THE ANCIENT EGYPTIAN HERITAGE AND ARCHAEOLOGY FUND NEWSLETTER

Issue 1

2015

Rebuilding the Palace

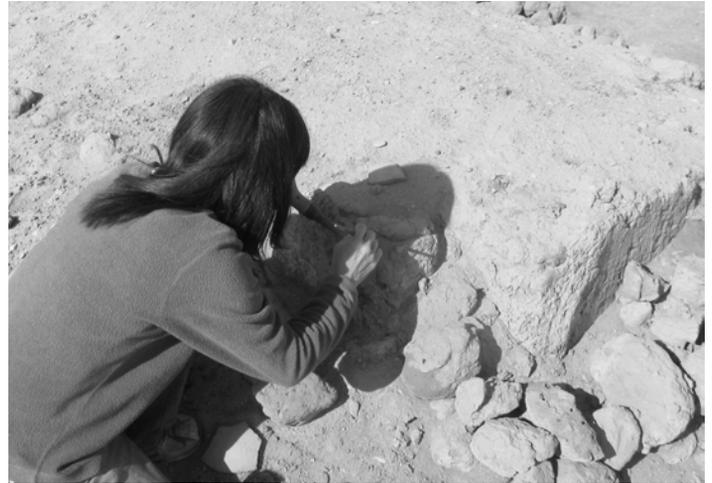
Hiroko cleaning and stabilizing the remaining wall painting in the King's Robing Room

This season the Fund sponsored the work of conservator Hiroko Kariya at the Palace of the King and together with Tony Crosby made preliminary recommendations for a long term conservation program for the painted mud plaster walls and the fragments that are still found scattered throughout the site. Her work included trial stabilization of the mud plaster and experimental reburial of the painted wall in the King's Bed Chamber. Various cleaning methods and consolidation materials were tested and a storage system was developed for the loose fragments of painting. Based on these tests, the most suitable consolidant and method will be chosen to conserve the remaining painted walls and floors still *in situ* throughout the Palace of the King and the numerous painted fragments will be collected, preserved and stored.

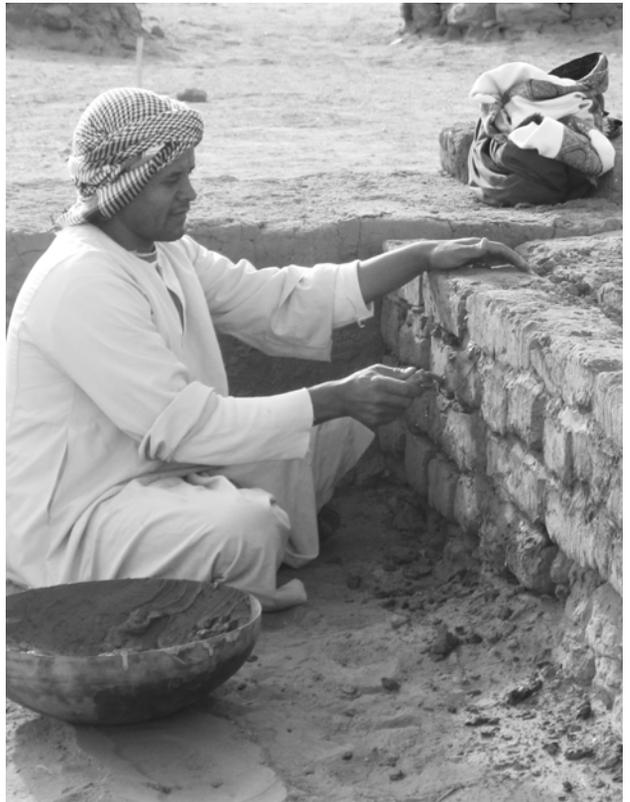
Pointing the new mud bricks

Walls that have eroded to the extent that a considerable portion of their thickness is missing present additional problems of stability. We try to see that the original thickness is restored, replicating the bonding and pointing patterns of the original brickwork and ensuring that this restoration is structurally connected to form a cohesive wall section.

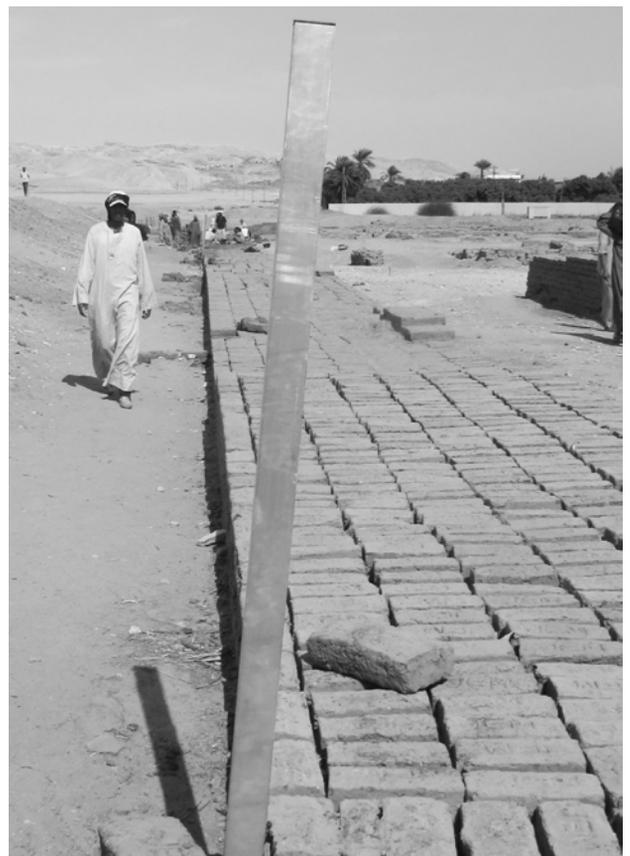
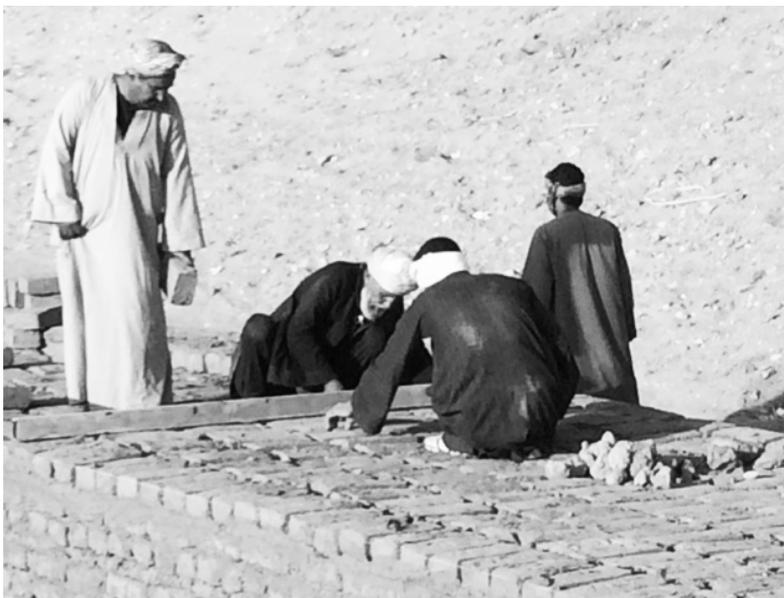
Restoration work on the battered exterior wall of the Palace

Doorways are defined where they are known to exist, as they are necessary to understand room uses and relationships. If evidence of a doorway does not exist, even though it may be suspected, it is not restored. Likewise, if the continuation of a wall is suspected, but physical evidence does not exist, the restored part is stepped down as a visual indicator of the absence of information. Some of the original walls are severely undercut and the bases have to be stabilized prior to any additional restoration.

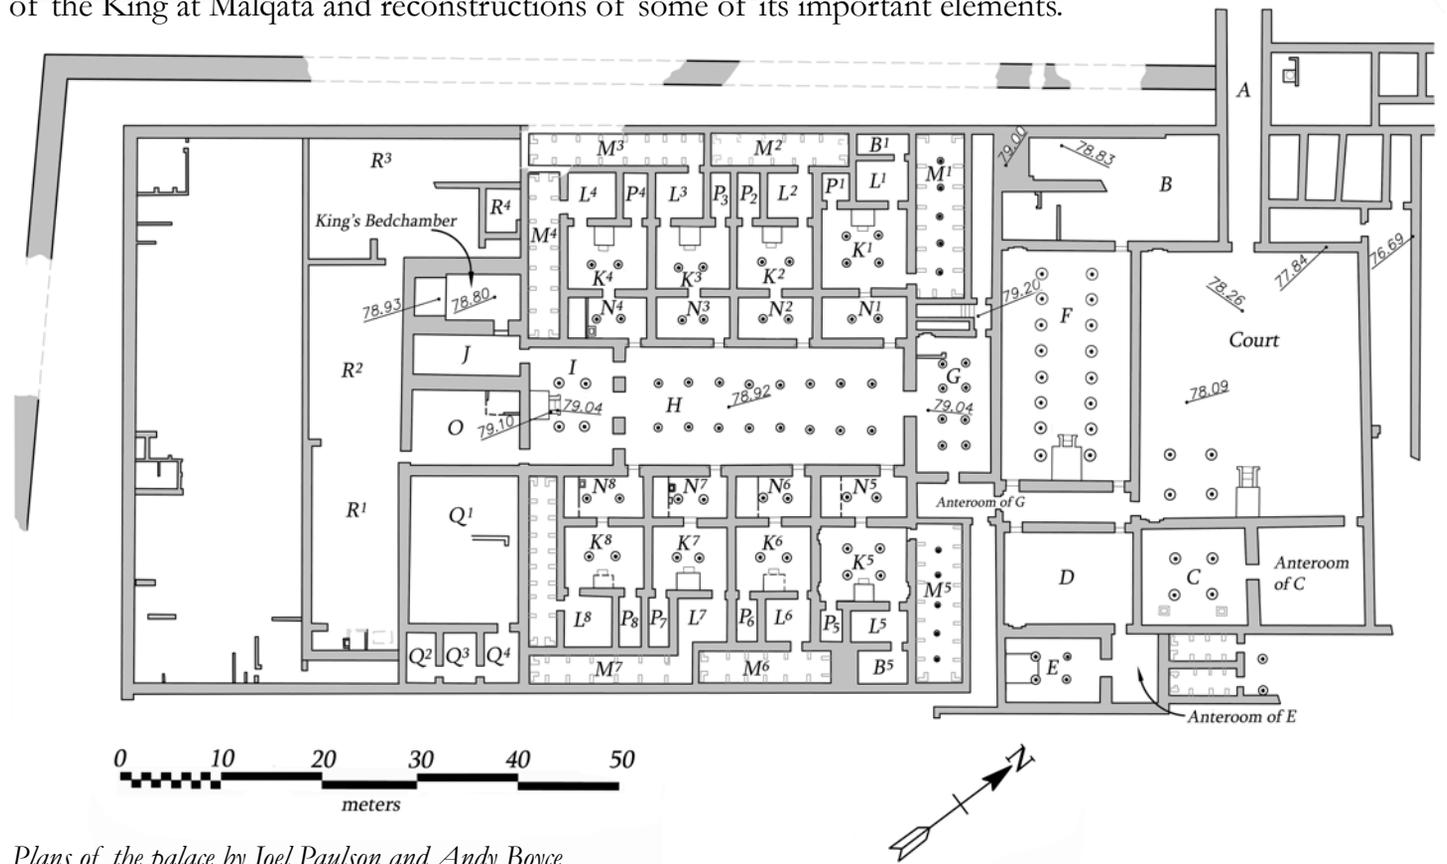
Plans of the palace by Joel Paulson and Andy Boyce

The Ancient Egyptian Heritage and Archaeology Fund helped underwrite the work of archaeological illustrator Andy Boyce in making new plans and drawings of the Palace of the King at Malqata and reconstructions of some of its important elements.
