Report on survey and restoration at Deir el-Ballas
From December 11 – 31, 2018

The Ancient Egyptian Heritage and Archaeology Fund conducted a season of survey, cleaning, recording and restoration to protect and restore the important Palace-City of Sekhenenre and Ahmose at Deir el-Ballas from December 11 – 31, 2018 (fig. 1).

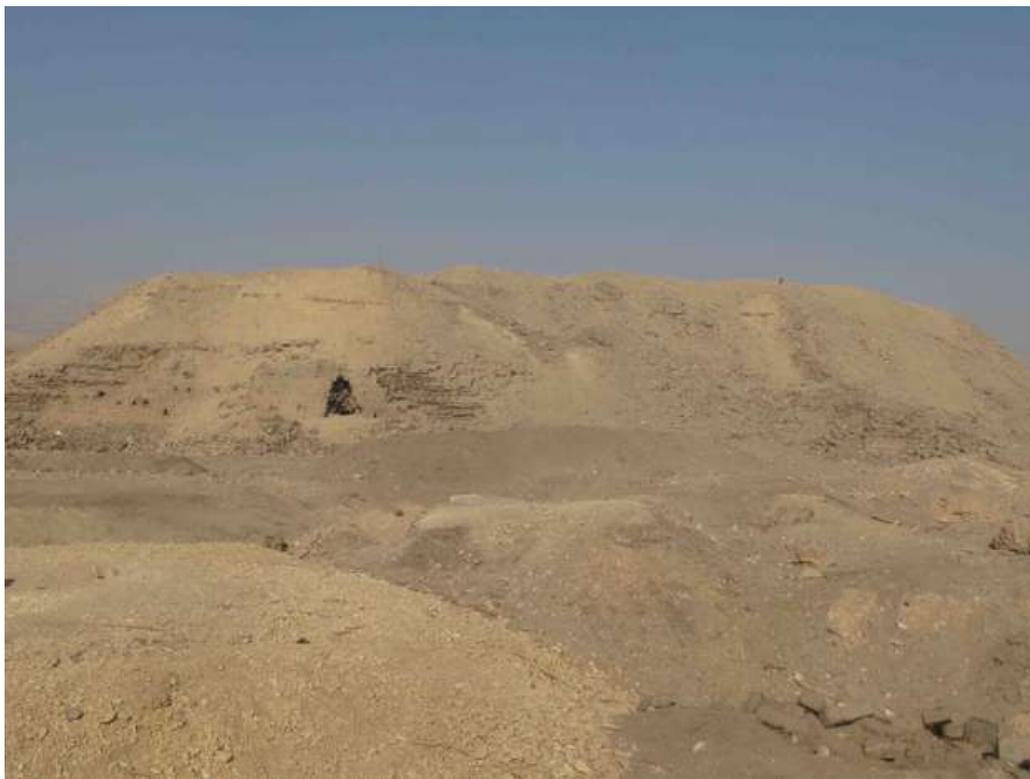
We began restoration efforts this season on the “South Palace,” which had suffered from looters emptying out some of the casemate foundations and digging holes in the façade of the eastern wall of the platform, which has caused significant parts of the brick facing to collapse (fig. 2). This was filled in with modern, unbaked mud bricks stamped with an AUC logo and made in the same size as the other “South Palace “bricks. [ca. 47 x 22 x 12 cm.] (figs. 3-4).

Fig. 2 Façade of the “South Palace” with hole caused by looters at beginning of work in 2018.

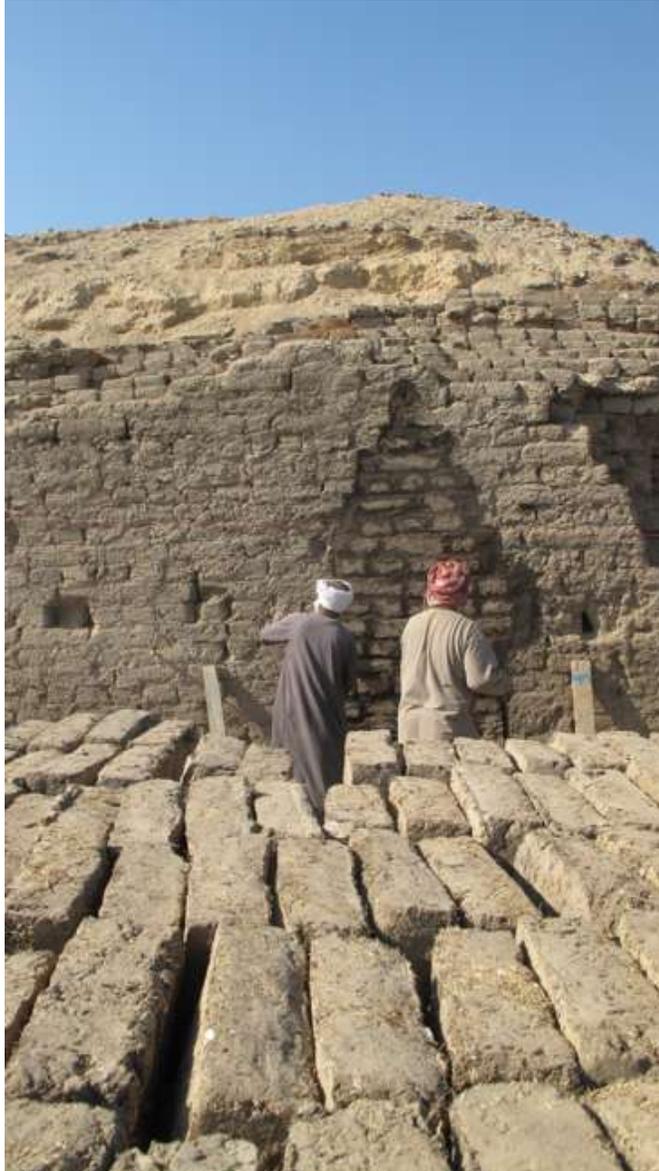
Fig. 3 Façade of the “South Palace” during filling of losses caused by looters.

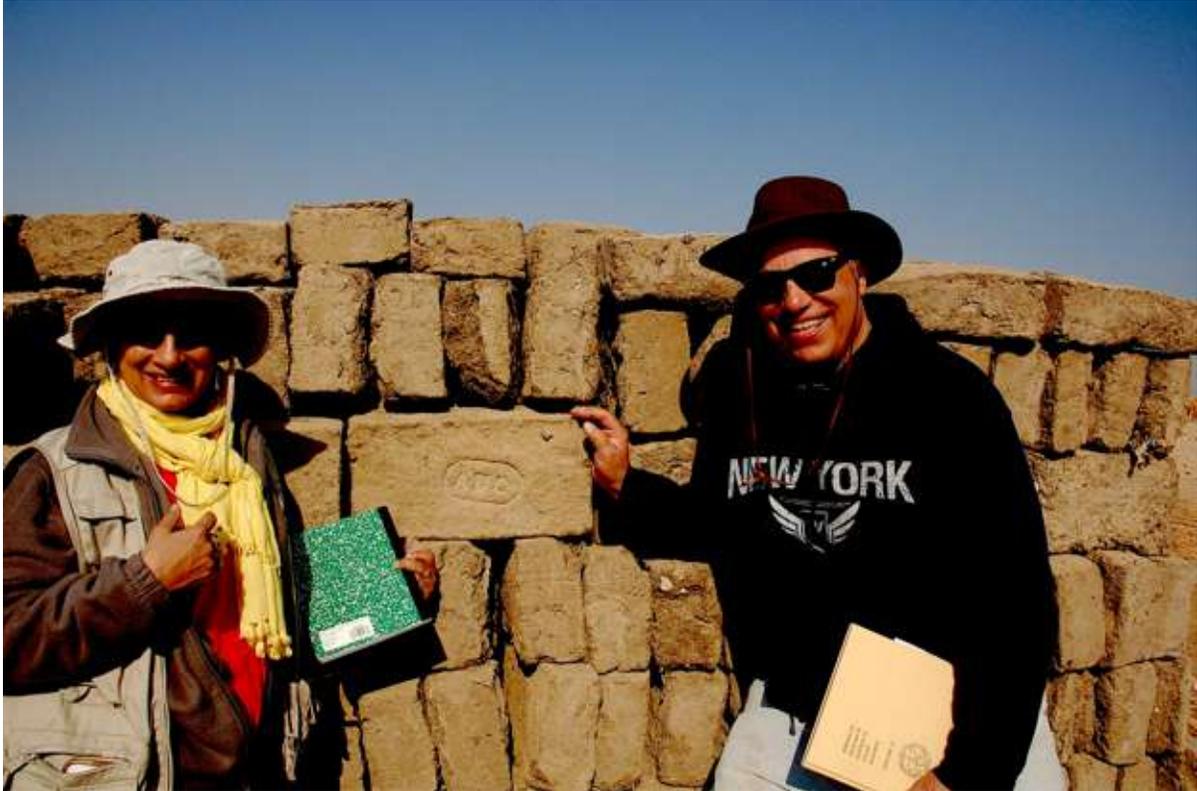
Fig. 4 New mud bricks made for the restoration of the “South Palace.”

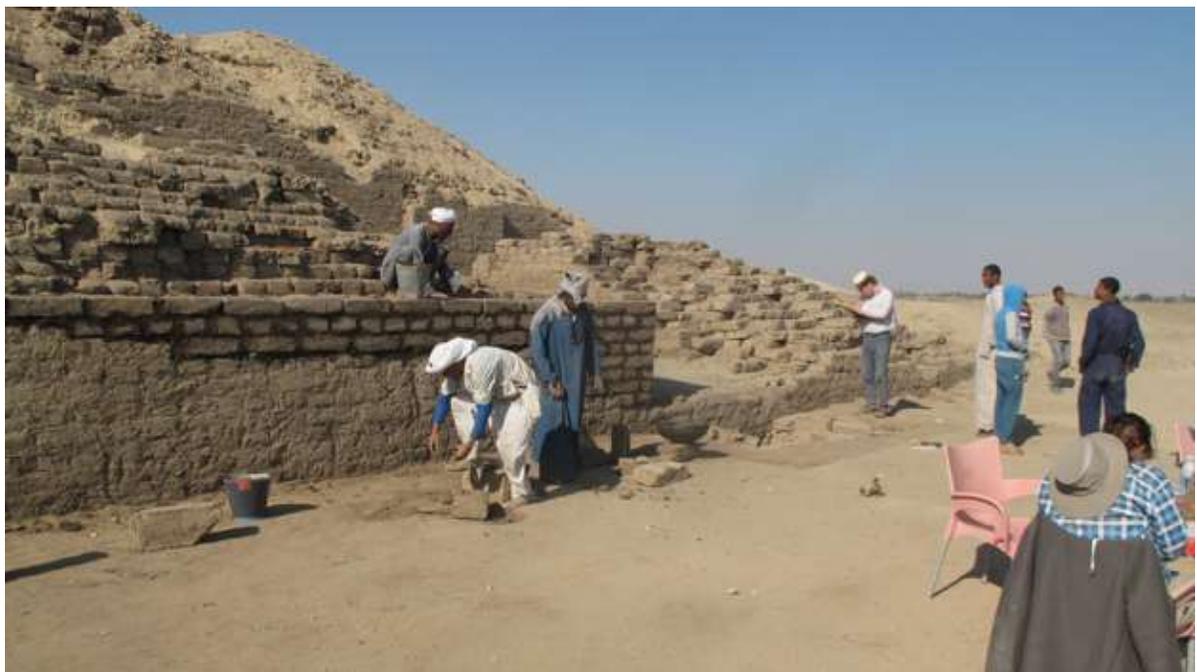
Fig. 5 A layer of geotextile mesh was added between the modern and ancient courses in the “South Palace” restoration.

A layer of geotextile mesh was added between the modern and ancient courses (fig. 5). We are most grateful to Mohammed Hussein, Conservator of the Qena District for his help and advice on the restorations.

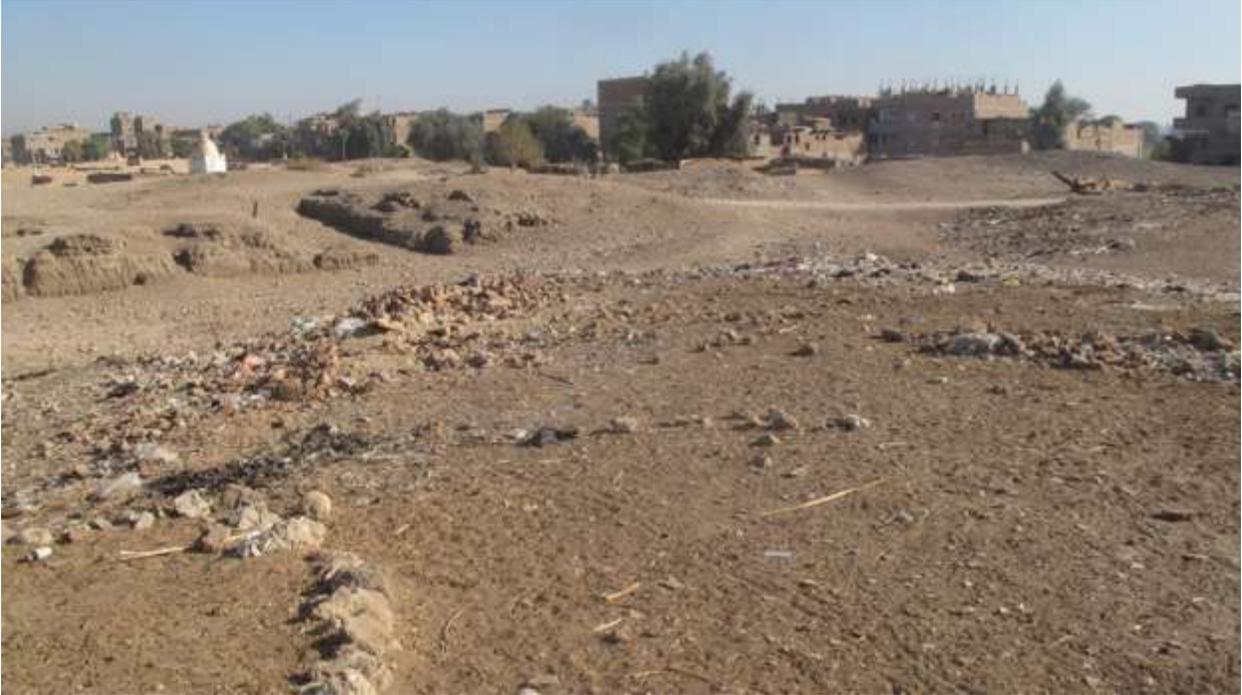
Fig. 6 Modern trash dumped beside the North Palace.

At the North Palace (fig. 6) we endeavored to clean up modern trash and debris littering the area. We are very thankful to the office of the Governor of Qena for his help in cleaning the debris in the area. We surveyed the area around the North Palace with the Inspectorate Office of Qena as to where best to build a protective wall around the Palace.

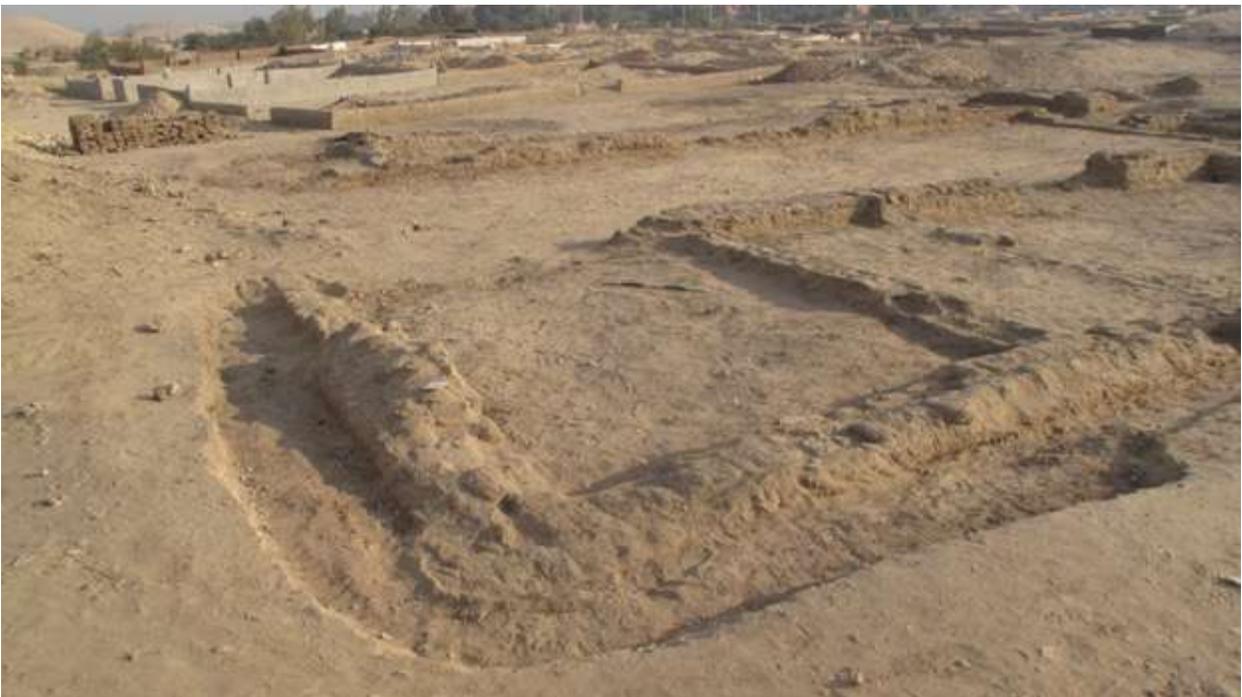
Fig. 7 House A by North Palace being encroached upon by modern cemetery.

Many of the ancient houses, the workmen’s village and associated chapels have been entirely destroyed. We also worked with the Inspectorate to determine where we might have a boundary to keep the modern cemetery from encroaching into the area of the ancient settlement. We cleared and surveyed one house in the area that had been exposed and recorded it and then recovered it (fig. 7). Fortunately, much of the other parts of the settlement have so far been preserved for the time being under the stacks of hay used by the village potters. These will need to be mapped and cleared and recorded in future seasons.
