## Report on survey and restoration at Deir el-Ballas

From December 11 – 31, 2018

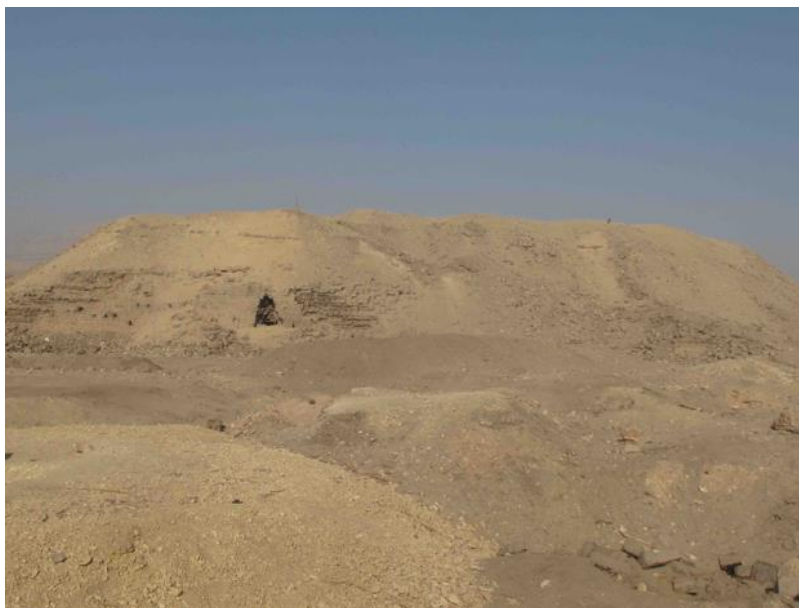
We began restoration efforts this season on the “South Palace,” which had suffered from looters emptying out some of the casemate foundations and digging holes in the façade of the eastern wall of the platform, which has caused significant parts of the brick facing to collapse (fig. 2). This was filled in with modern, unbaked mud bricks stamped with an AUC logo and made in the same size as the other “South Palace “bricks. [ca. 47 x 22 x 12 cm.] (figs. 3-4 ).

Fig. 2 Façade of the “South Palace” with hole caused by looters at beginning of work in 2018.

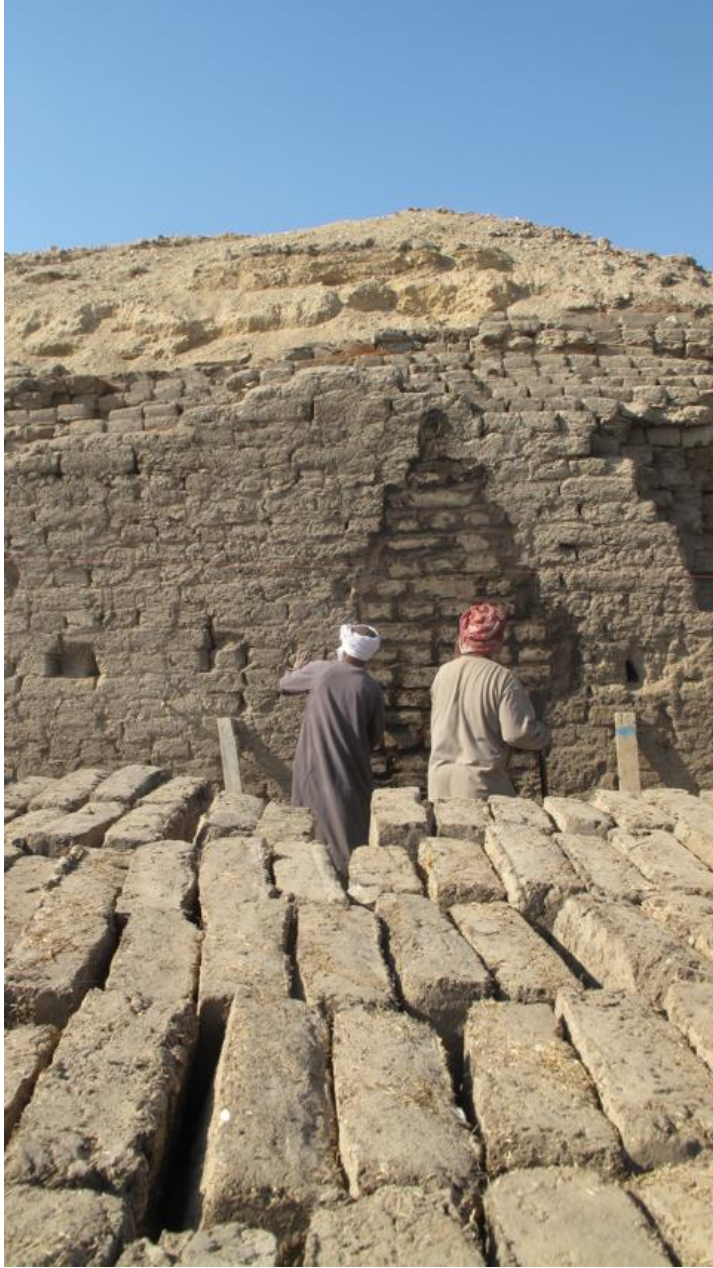
Fig. 3 Façade of the “South Palace” during filling of losses caused by looters.

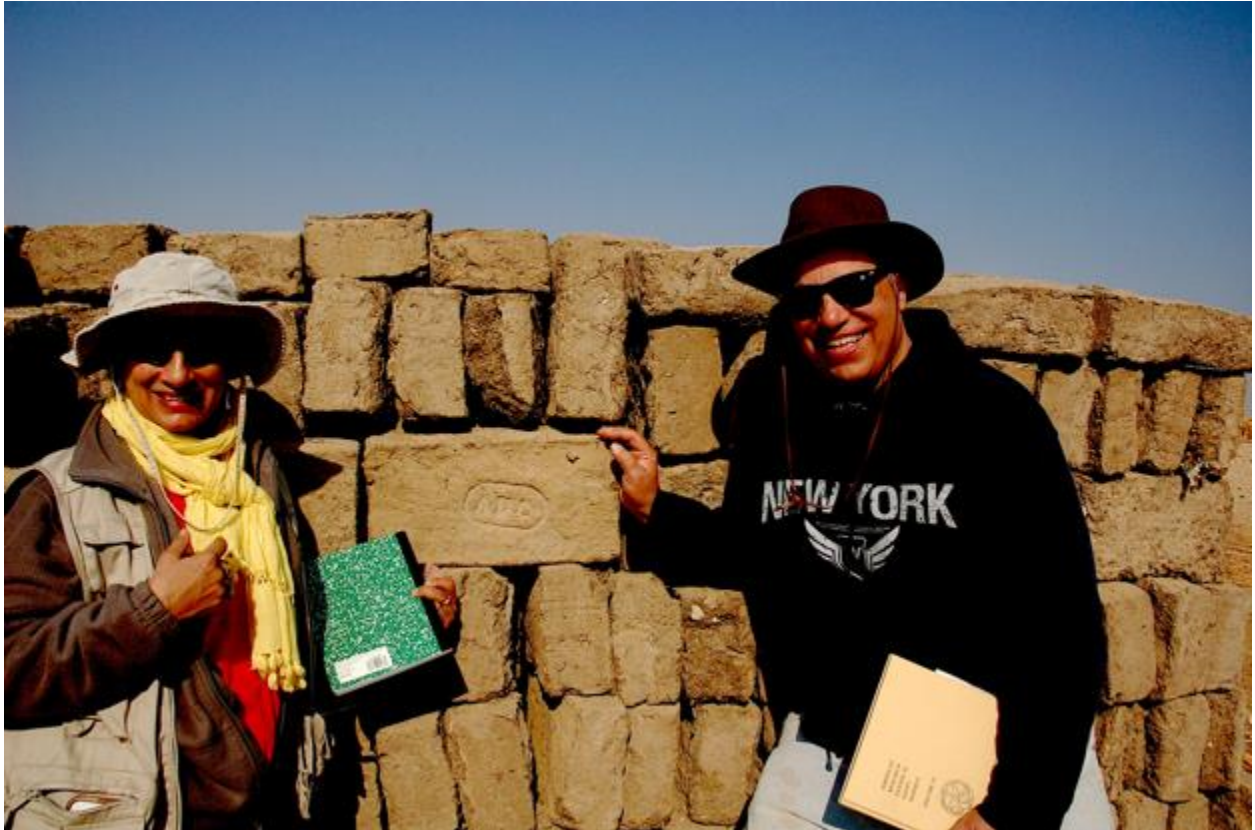
Fig. 4 New mud bricks made for the restoration of the “South Palace.”

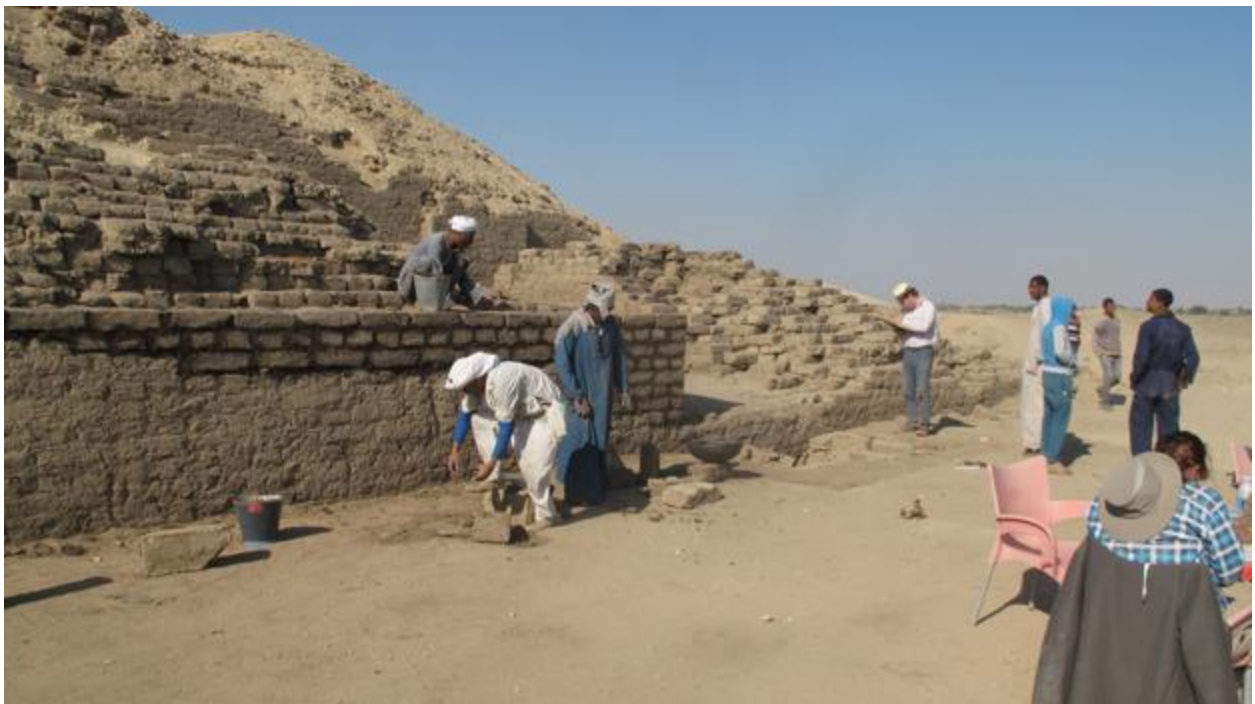
Fig. 5 A layer of geotextile mesh was added between the modern and ancient courses in the “South Palace” restoration.

A layer of geotextile mesh was added between the modern and ancient courses (fig. 5). We are most grateful to Mohammed Hussein, Conservator of the Qena District for his help and advice on the restorations.

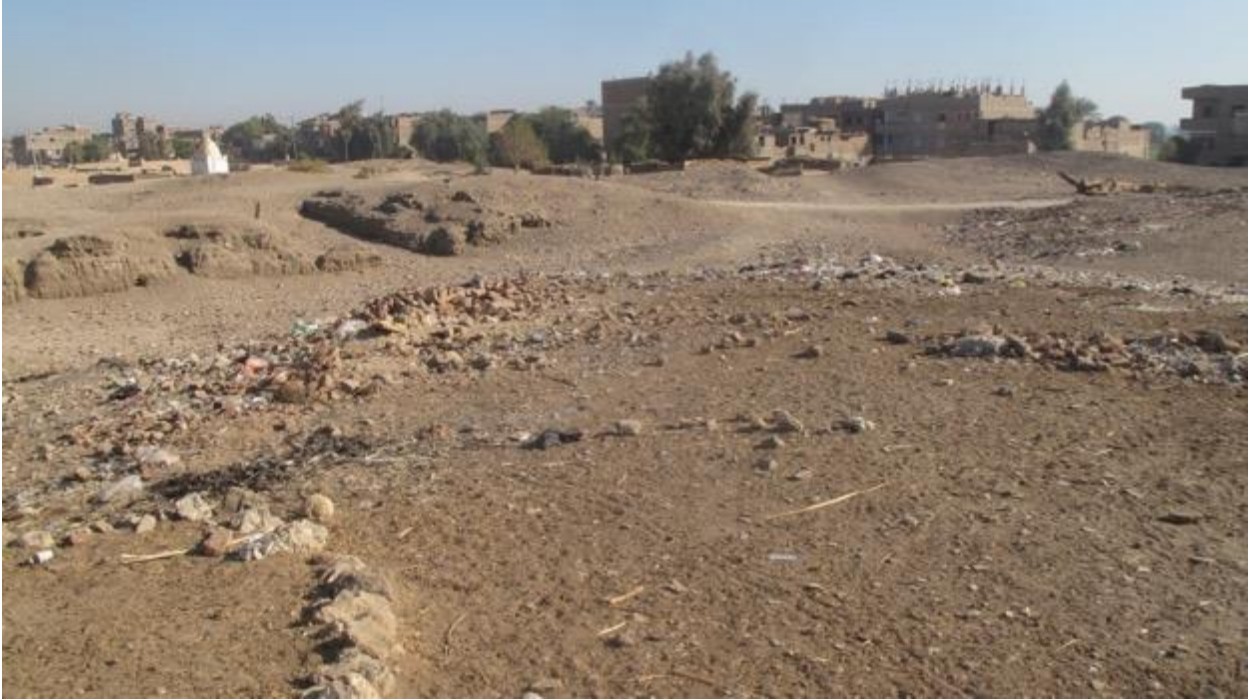
Fig. 6 Modern trash dumped beside the North Palace.

At the North Palace (fig. 6) we endeavored to clean up modern trash and debris littering the area. We are very thankful to the office of the Governor of Qena for his help in cleaning the debris in the area. We surveyed the area around the North Palace with the Inspectorate Office of Qena as to where best to build a protective wall around the Palace.

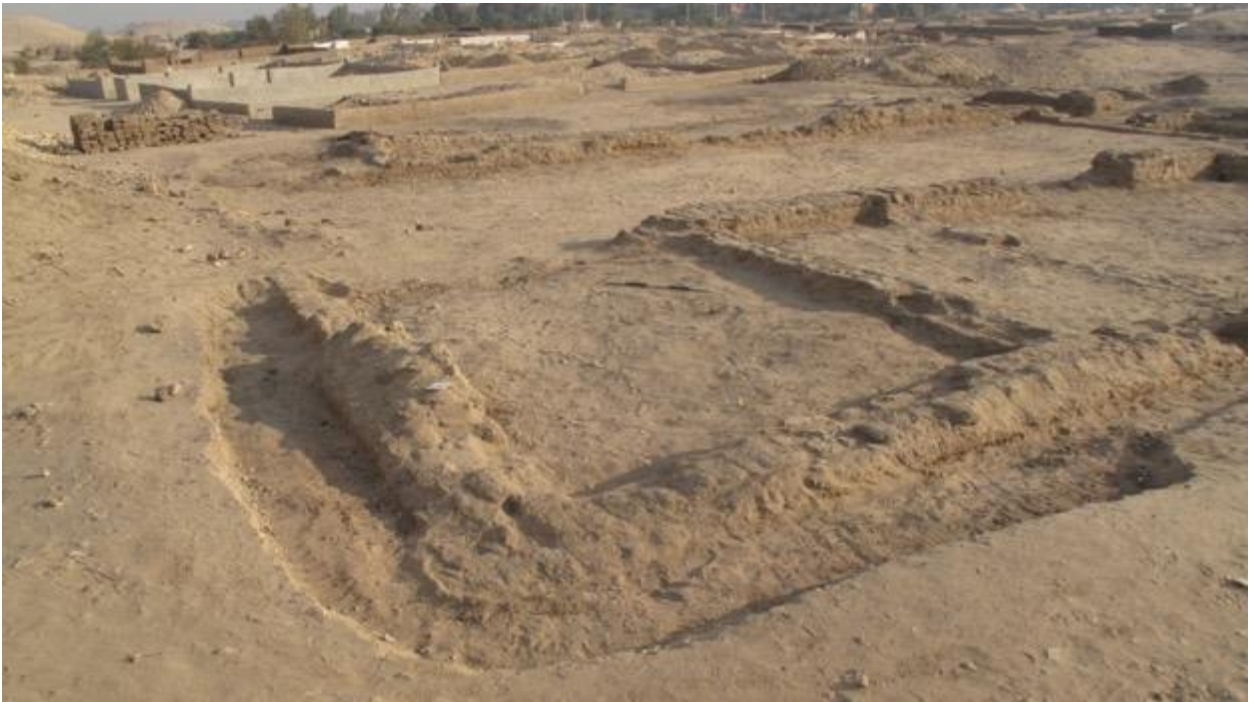
Fig. 7 House A by North Palace being encroached upon by modern cemetery.

Many of the ancient houses, the workmen’s village and associated chapels have been entirely destroyed. We also worked with the Inspectorate to determine where we might have a boundary to keep the modern cemetery from encroaching into the area of the ancient settlement. We cleared and surveyed one house in the area that had been exposed and recorded it and then recovered it (fig. 7). Fortunately, much of the other parts of the settlement have so far been preserved for the time being under the stacks of hay used by the village potters. These will need to be mapped and cleared and recorded in future seasons.
