Report on survey of Deir el-Ballas  
From January 11 – 24, 2017

The Ancient Egyptian Heritage and Archaeology Fund conducted a short initial season of survey and recording in order to figure out ways to protect and restore the important Palace-City of Sekhnenre and Ahmose at Deir el-Ballas (fig. 1).

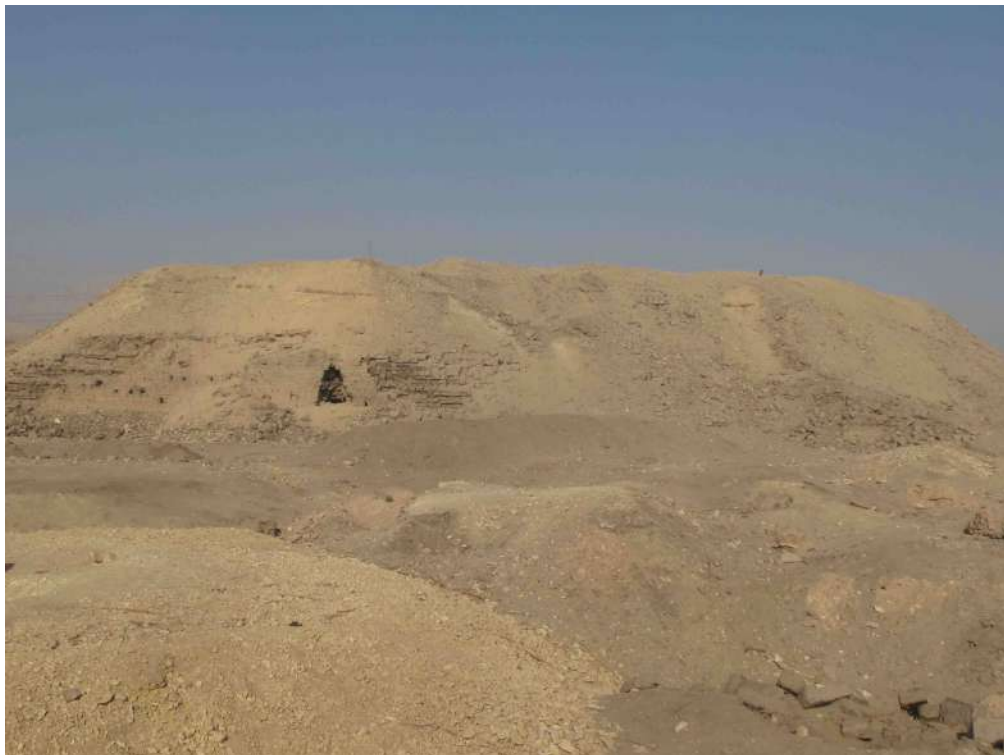
The team consisted of Peter Lacovara as Director along with Piet Collet, as surveyor and Tom Hardwick and Victoria Jensen, archaeologists. The work was greatly facilitated by Hasaan Mohamed Ail. We concentrated this season on the “South Palace” which had suffered from looters emptying out some of the casemate foundations and digging holes in the façade of the eastern wall of the platform, which has caused significant parts of the brick facing to collapse. (figs. 2- 3)

Fig. 3 Façade of “South Palace.”

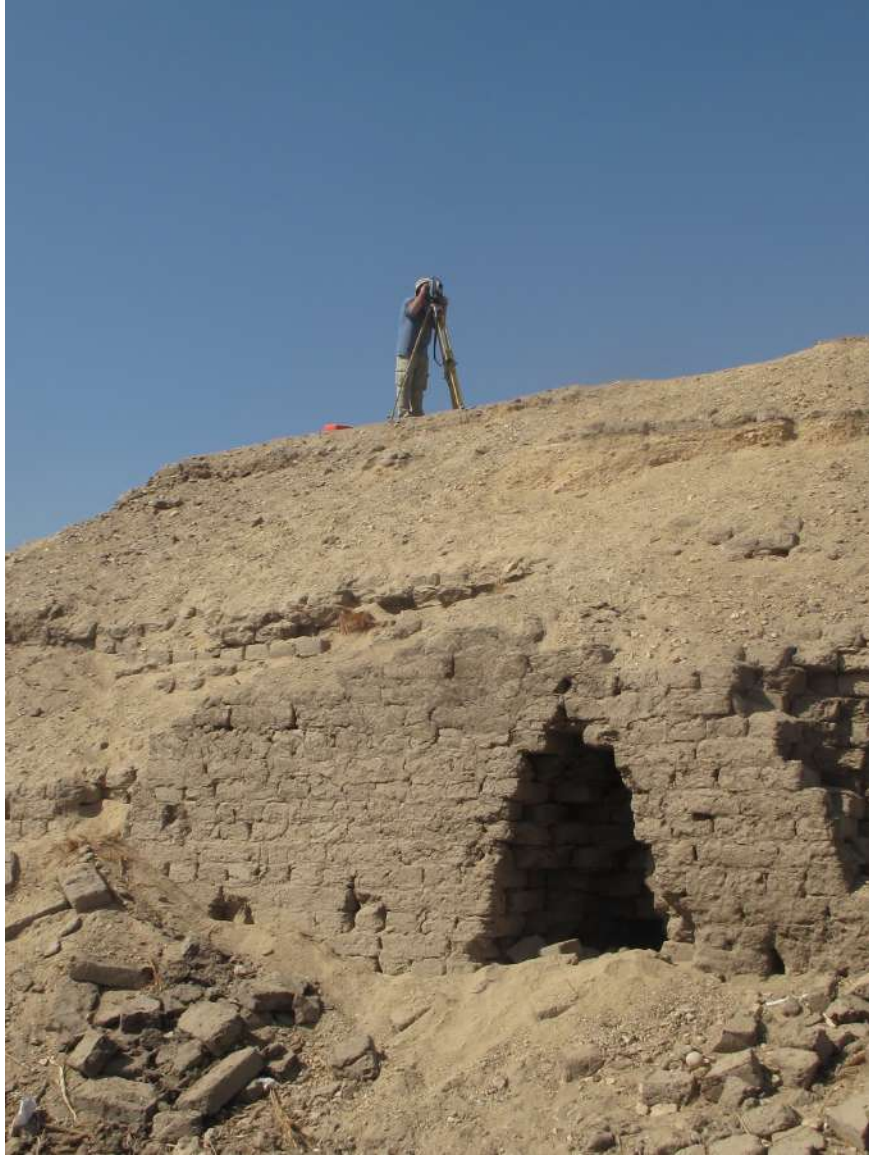
Fig. 4 Piet Collet surveying on top of the “South Palace.”

To record the current condition of the structure, it was photographed and surveyed by Piet Collet. (fig. 4) In addition, a number of exposed sections of casemates and casemate fill were planned and photographed to better understand the construction. (fig. 5) We also endeavored to clean up modern trash and debris littering the area. Piet Collet also surveyed the entire ancient site and we conducted a walking survey to assess its condition. The areas of the Workmen’s Village and associated chapels have been entirely destroyed. Fortunately, much of the other parts of the settlement have so far been preserved for the time being under the stacks

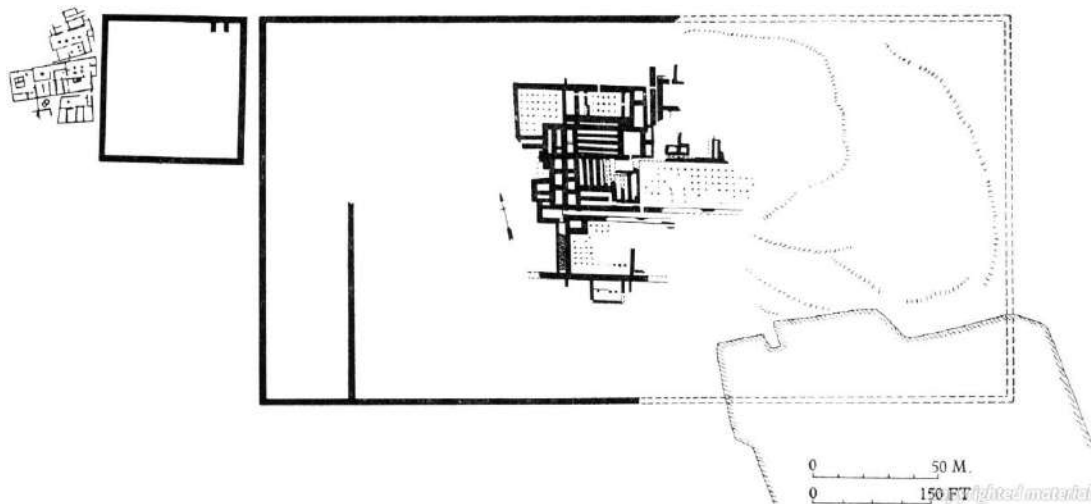
Fig. 6 Plan of the North Palace by Reisner in 1900

The North Palace is being encroached upon by the spread of the modern town and cemeteries, so it is critical to find a way to protect and restore this important structure. (fig. 6) As part of the program this season the area around the North Palace was surveyed to plan for a protective wall to be built around the structure in coming seasons.

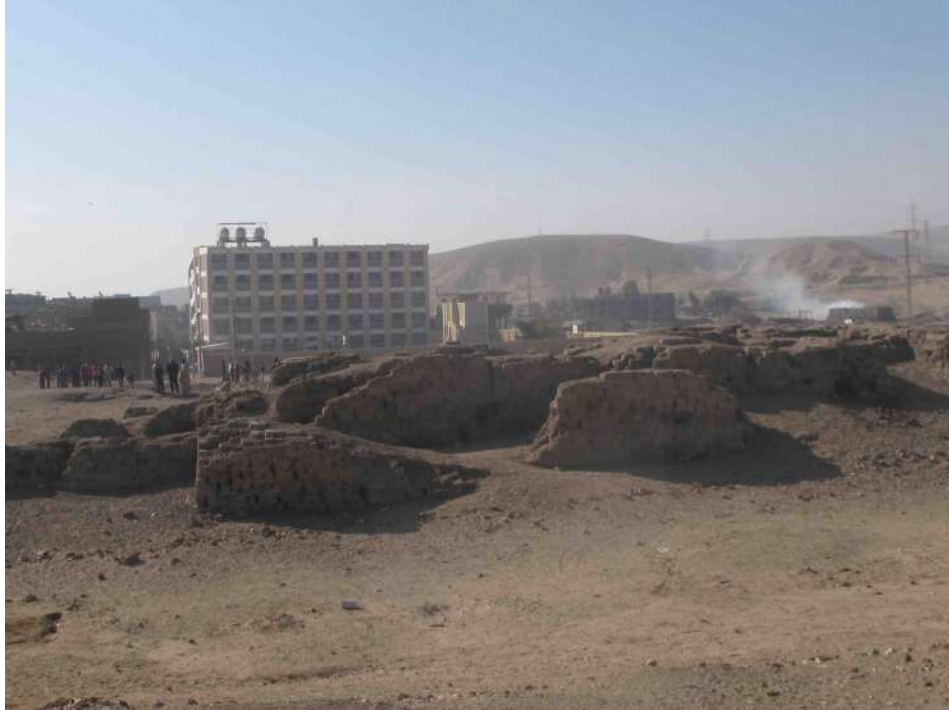
Fig. 7 Photograph of the North Palace, showing the encroachment of the modern village.
