THE ANCIENT EGYPTIAN HERITAGE AND ARCHAEOLOGY FUND

Deir el-Ballas Report for Qena Inspectorate Office

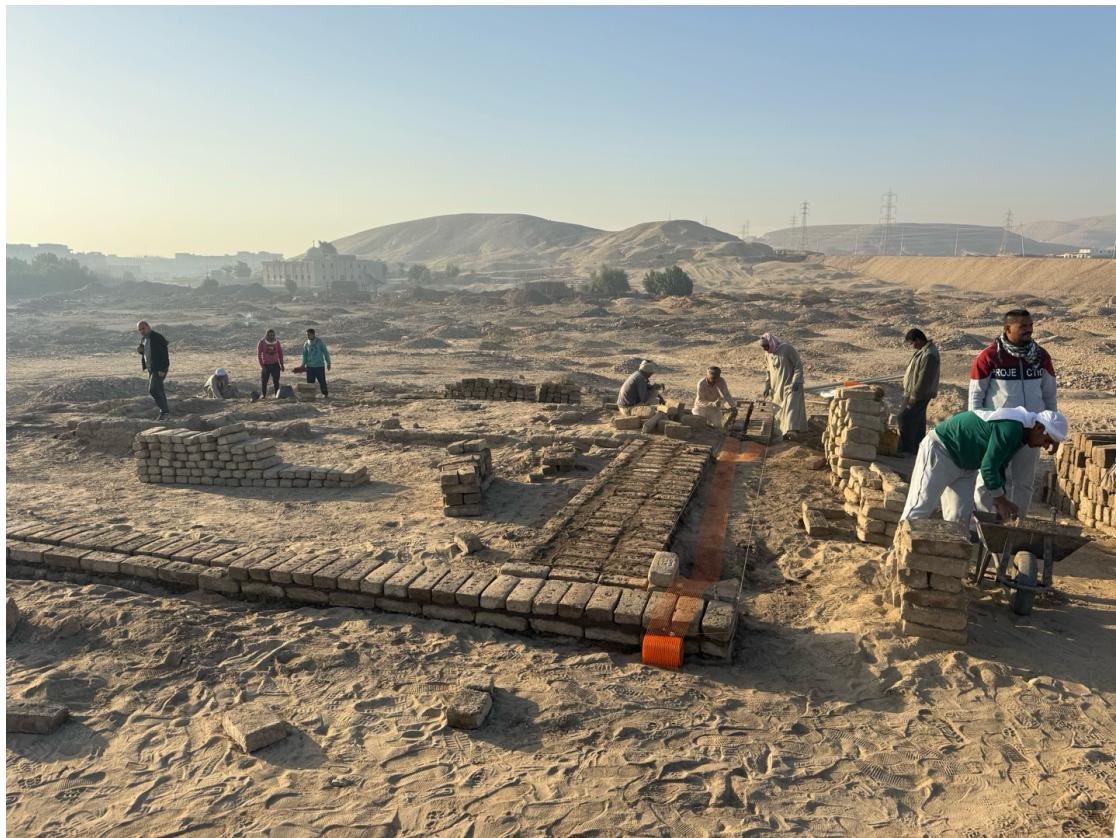
Fig. 1 Restoration and stabilization work at House F.

Conservation and stabilization work progressed across the site. Restoration at House F was completed, including the capping of walls, stabilization of architectural features, and protection of floors with clean sand. These efforts will safeguard the structure from further deterioration and modern encroachment while preserving the architectural integrity of the house. At the North Palace, restoration work continued on the casemate walls and enclosure features, with teams capping exposed mudbrick and filling losses to stabilize standing remains.

Archaeological and documentation work continued in multiple areas of the site, integrating excavation, conservation, and recording. At House F, Ahmed Abdelgawad and his team completed restoration and capping of walls, while Benjamin Johnson documented several newly identified mudbrick walls uncovered this season on the structure's north and south sides. These architectural features suggest changes in circulation and room use within the building and will be incorporated into future publications. Restoration work at House F is now substantially complete.

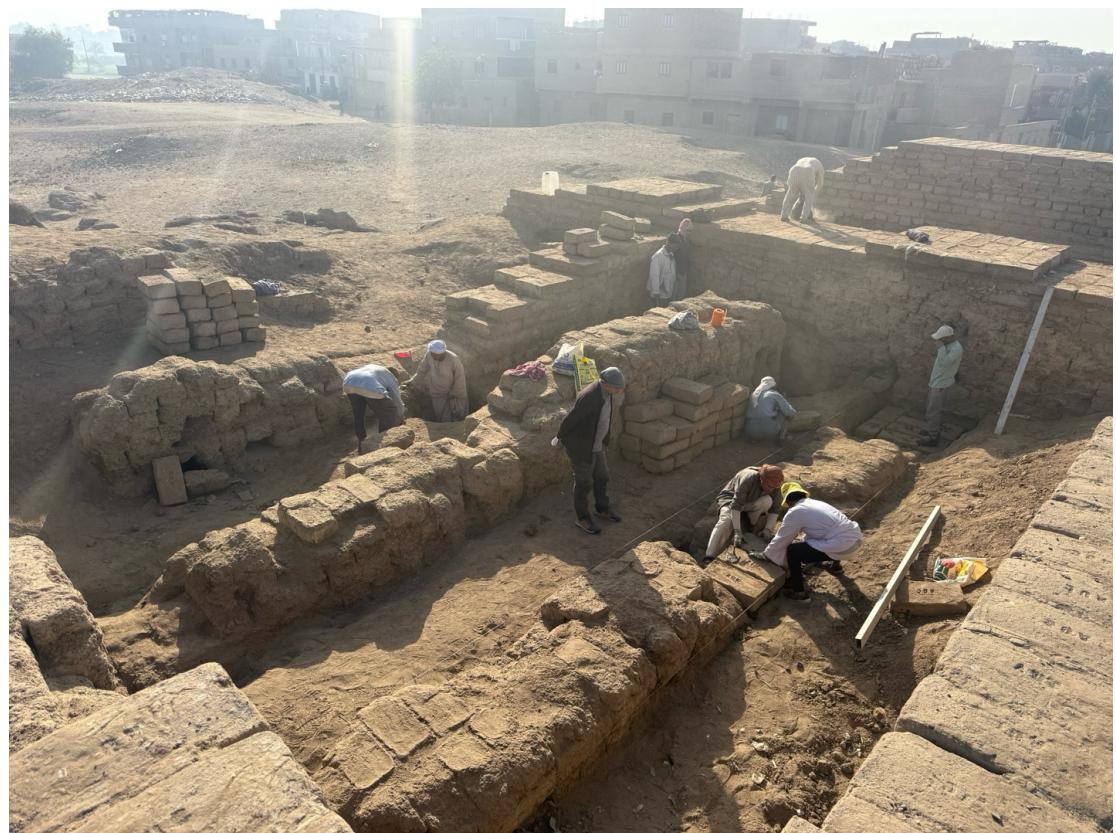
Fig. 2 Conservation work at the North Palace casemate walls.

At the North Palace, Ahmed Abdelgawad continued conservation work on the casemate walls and enclosure features. Cleaning, capping, and stabilization of exposed mudbrick progressed throughout the season. Gillian Pyke initiated targeted fieldwork east of the casemate core to investigate Late Antique occupation layers in an area that appears largely unexcavated on earlier maps. This work has begun to clarify the later history of the palace and its reoccupation phases.

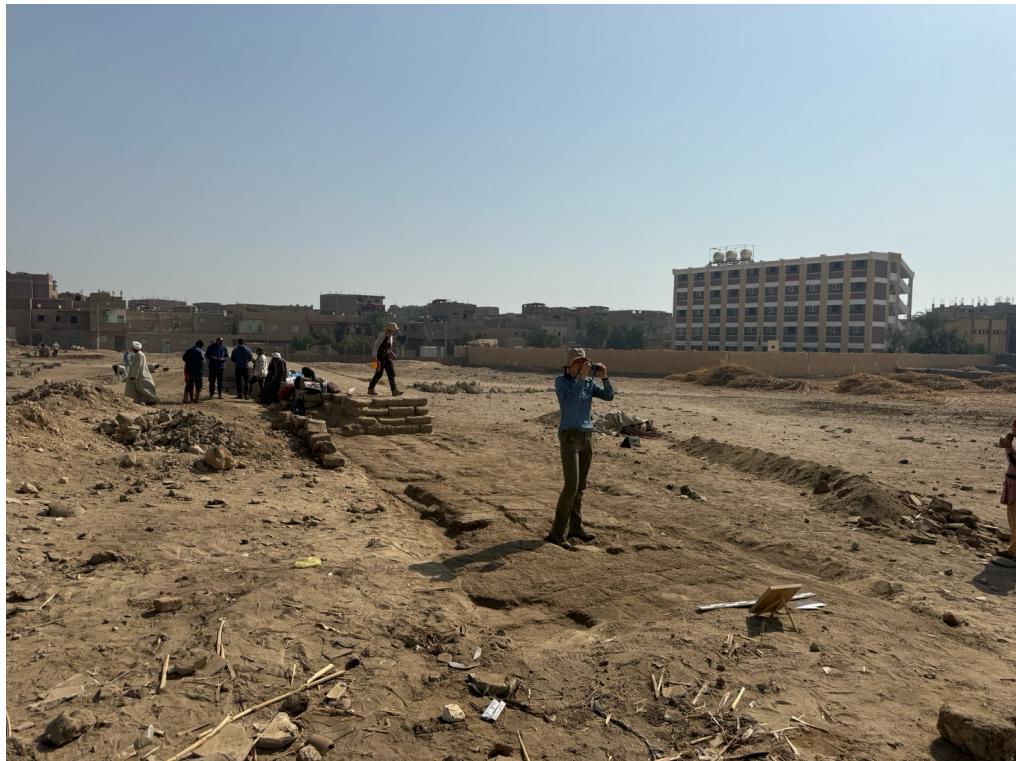
Fig. 3 Clearance and documentation of the North Palace Enclosure Wall.

At the North Palace Enclosure Wall, workmen completed the stabilization of the wall's foundations and capped remaining mud brick to protect underlying archaeological deposits. This capping will also function as the foundations in preparation for the construction of a wall storage facility for archaeological materials in a forthcoming season. This represents a critical step toward improving on-site conservation and long-term storage of archaeological materials, such as broken pottery, charcoal, flint debris, and botanical remains. Mud brick production also began in preparation for a future season's planned conservation efforts.

Work also continued along the North Palace Enclosure Wall. Sarah Sowerby and Fiona Burdette supervised the clearance cleaning of backfill from previously excavated wall segments and documented their findings in preparation for restoration. In the interior of the enclosure, Amalee Bowen, Waleed Hawatky, Victoria Shakespeare, and Benjamin Johnson documented newly exposed walls, collapse deposits, and stratigraphic profiles in two trenches. Detailed profile drawings were completed in the southern trench, providing an updated stratigraphic record that differs in key respects from early twentieth-century plans which are blank on Reisner's maps.

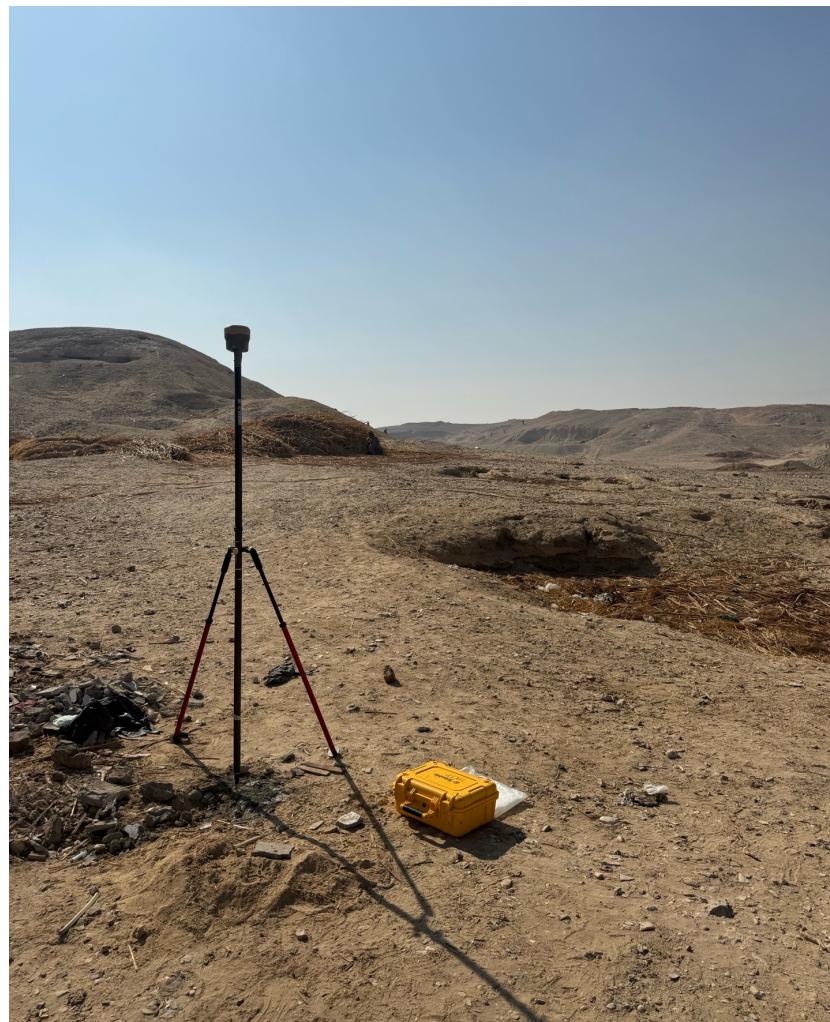
Fig. 4 Establishment of site grid and fix points across Deir el-Ballas.

A major milestone this season was the establishment of a permanent site grid and fix point system. Under the supervision of Sarah Sowerby, the team installed and recorded 31 permanent survey nails across the site using a Trimble GNSS R12 system. These fixed reference points provide the foundation for accurate mapping, photogrammetry, and future planning and will support all subsequent archaeological and conservation work at Deir el-Ballas. A complete list of coordinates for these fix points is provided in **Appendix A**.

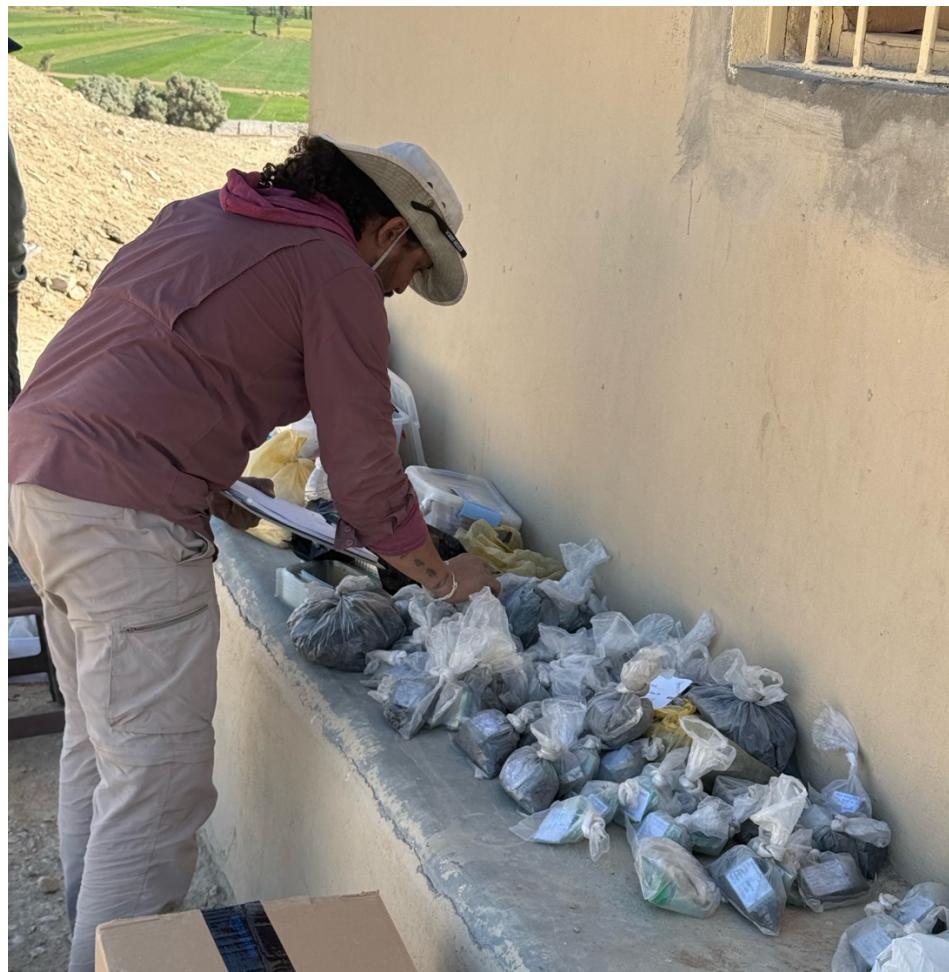
Fig. 5 On-site magazine work and rehousing of stored materials.

A major effort was devoted to reorganizing, inventorying, and rehousing stored materials from previous seasons. The team improved preservation conditions by introducing new storage containers within *shawal* bags and implementing a revised bag-numbering system. Charcoal samples, pottery, bones, lithics, and other miscellaneous materials were reorganized by area and context to improve accessibility and long-term curation for specialists.

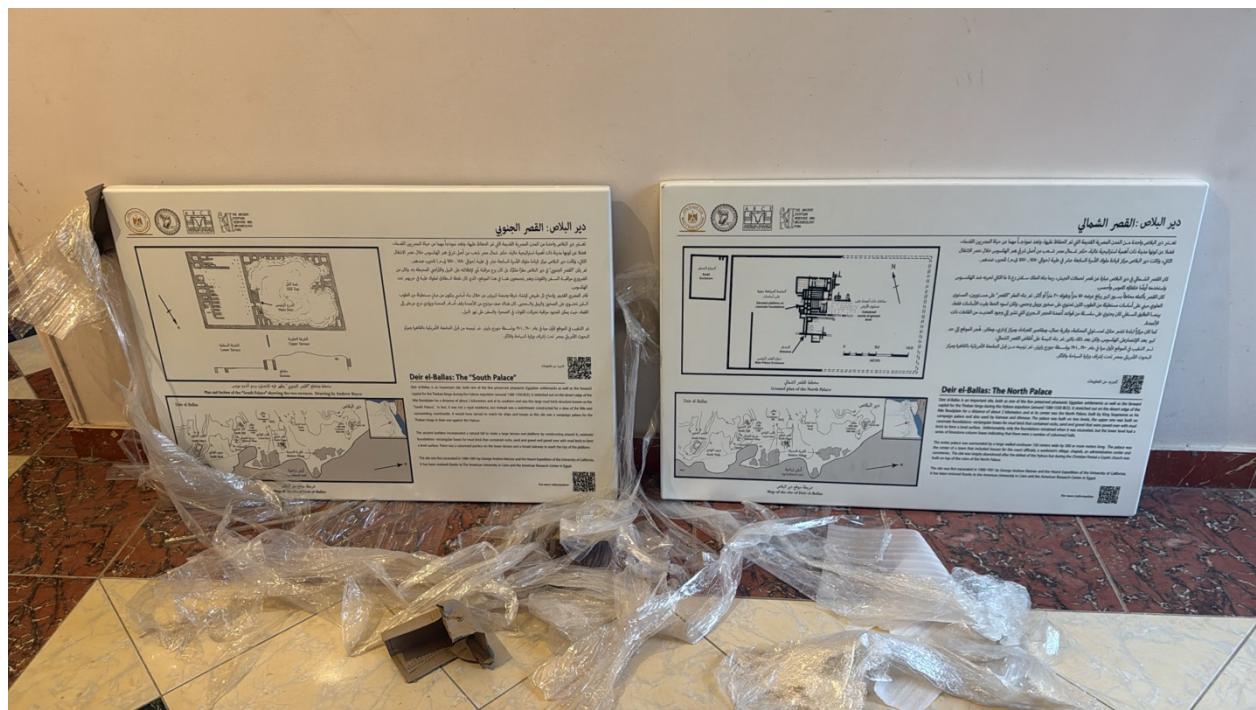
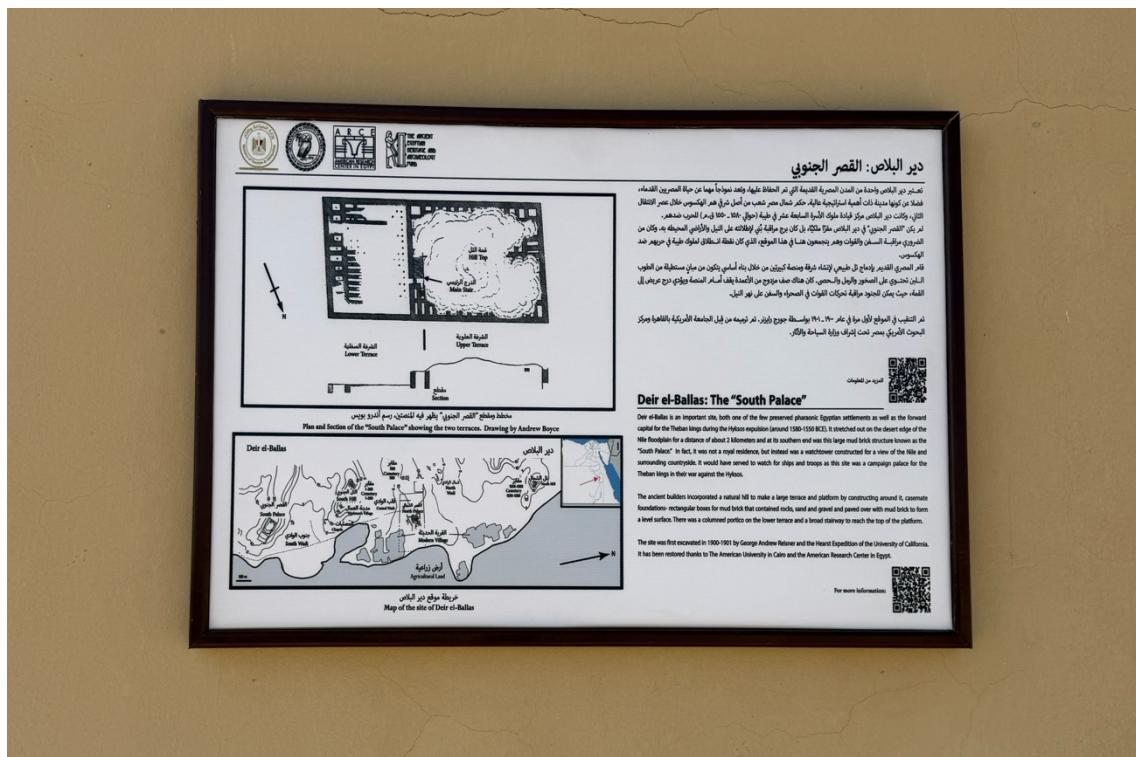
Fig. 6 Aluminum site signs for the North Palace and South Palace in storage, and a temporary sign installed at the South Palace workroom.

The Expedition also completed the design and printing of two permanent aluminum site signs in Cairo, one for the South Palace and one for the North Palace. Written in both Arabic and English, these panels were produced in consultation with Dr. Basem Ibrahim and the Site Development Department of the Ministry of Tourism and Antiquities and conform to the Ministry's signage guidelines.

In coordination with the Ministry, it was agreed to delay the installation of the permanent metal signs until the site is formally opened for tourism and appropriate locations can be selected following further archaeological investigation and excavation. In the interim, a temporary panel was installed at the South Palace workroom as a test case to evaluate how the signage performs on site during the off-season while the Expedition is absent (Fig ____).
